Pentium® III Xeon™ Processor Specification Update

Release Date: June 1999

Order Number: 244460-003

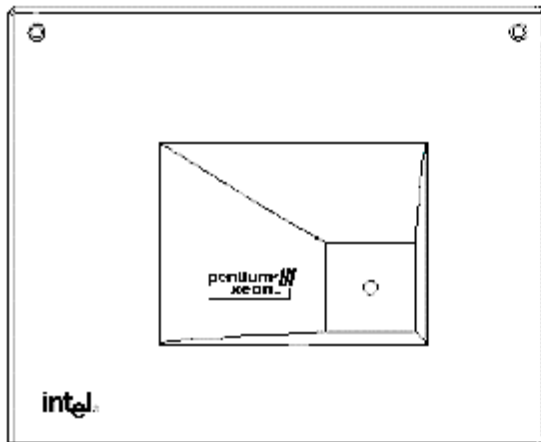
Pentium® III Xeon™ and Boxed Pentium® III Xeon™ Processor Markings

Production Dynamic Mark Example:

500/512/100/2.0V S1
 FFFFFFFF-NNNN {country}
 i®©'98 SSSSS

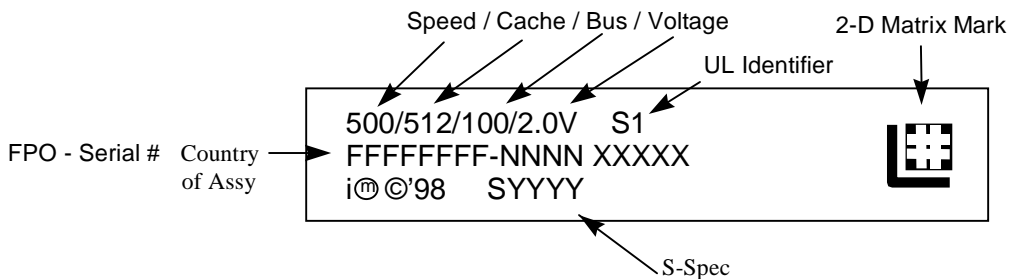
Dynamic Mark Area

Intel 80525PY500512
 FFFFFFFF-NNNN
